NATIONAL DAM INSPECTION REPORT. KAERCHER CREEK DAM (PA-00722), --ETC(U)

KAERCHER CREEK DAM  
BERKS COUNTY, PENNSYLVANIA  
NATIONAL I.D. NO. PA 00722

PHASE I INSPECTION REPORT  
NATIONAL DAM INSPECTION PROGRAM

Name of Dam: Kaercher Creek Dam  
County Located: Berks County  
State Located: Pennsylvania  
Stream: Kaercher Creek  
Coordinates: Latitude 40° 33.4' Longitude 75° 58.2'  
Date of Inspection: 18 July 1978

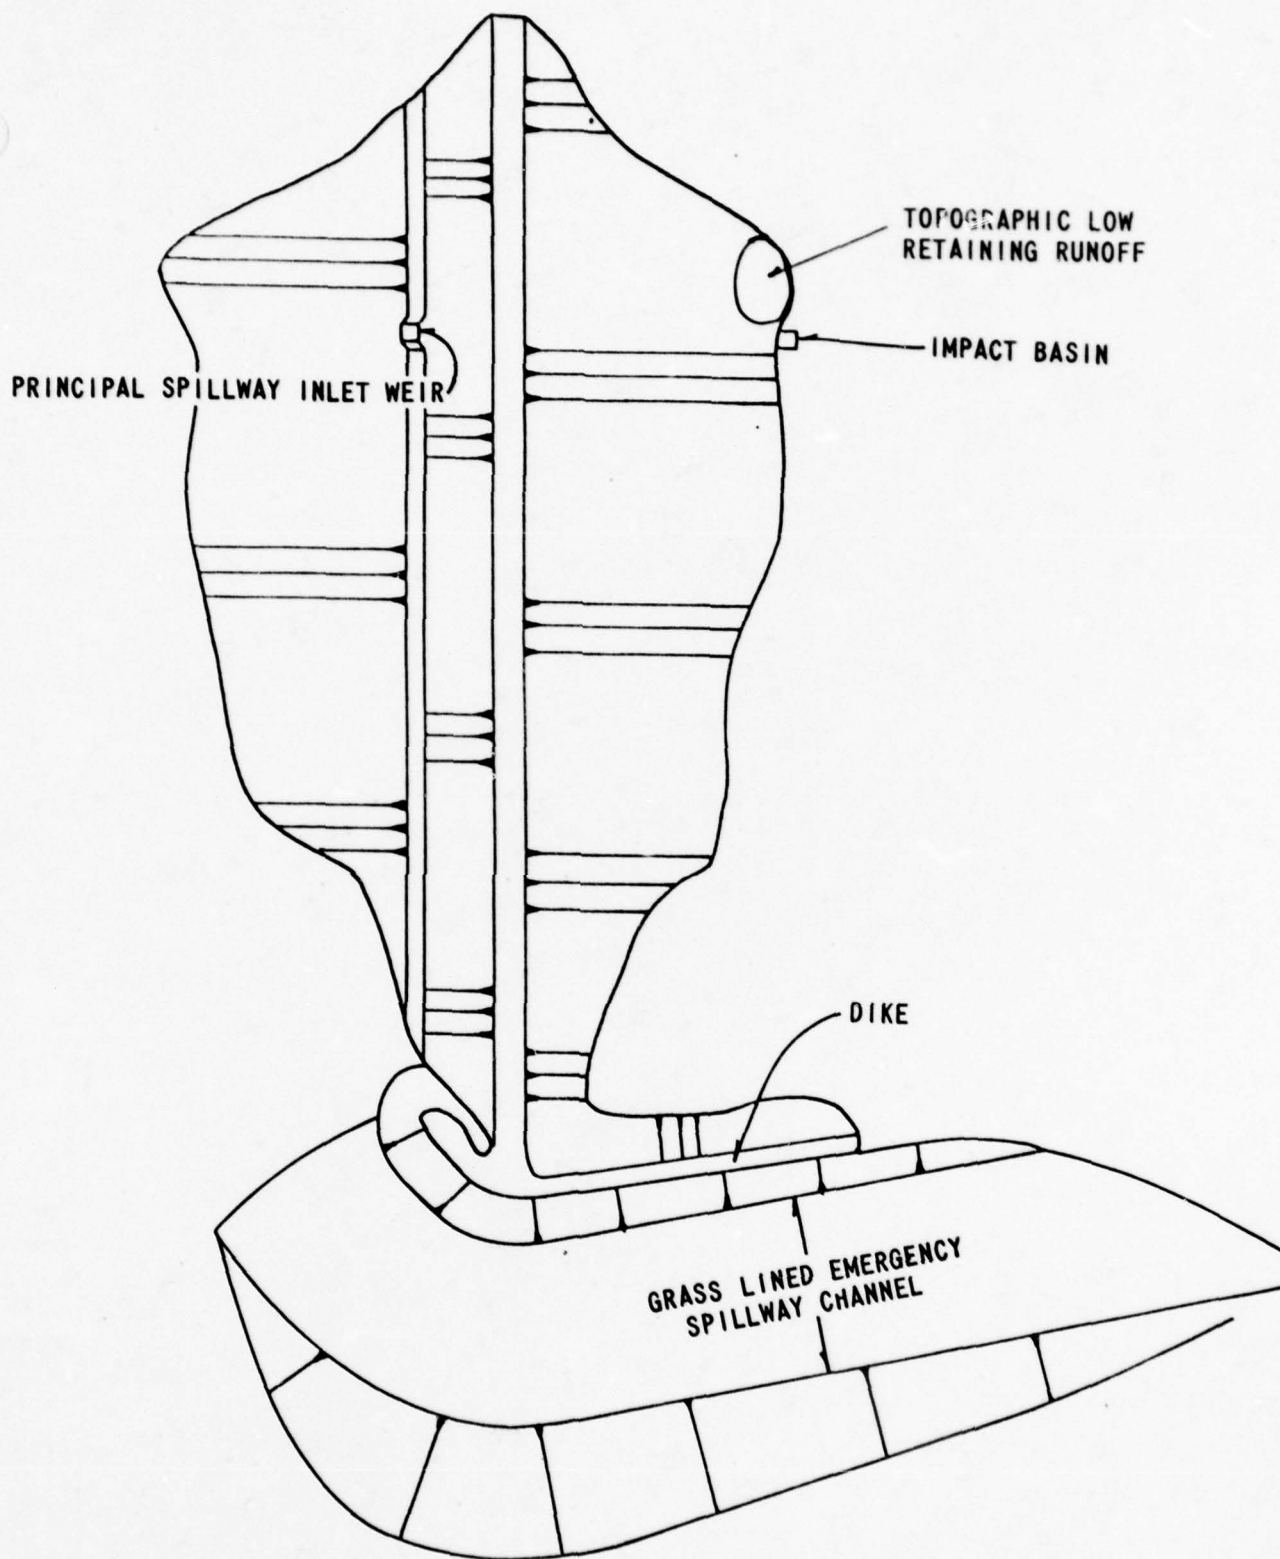
SHEET 5a OF 11

*None observed on downstream side of the dam or around outlet works. Some standing water was observed just left of the impact basin. The area is a topographic low approximately 15 feet in diameter. There was no evidence to indicate the area was a source of seepage. See sheet 5a for the specific location.*

SEEPAGE LOCATION PLAN  
KAERCHER CREEK DAM

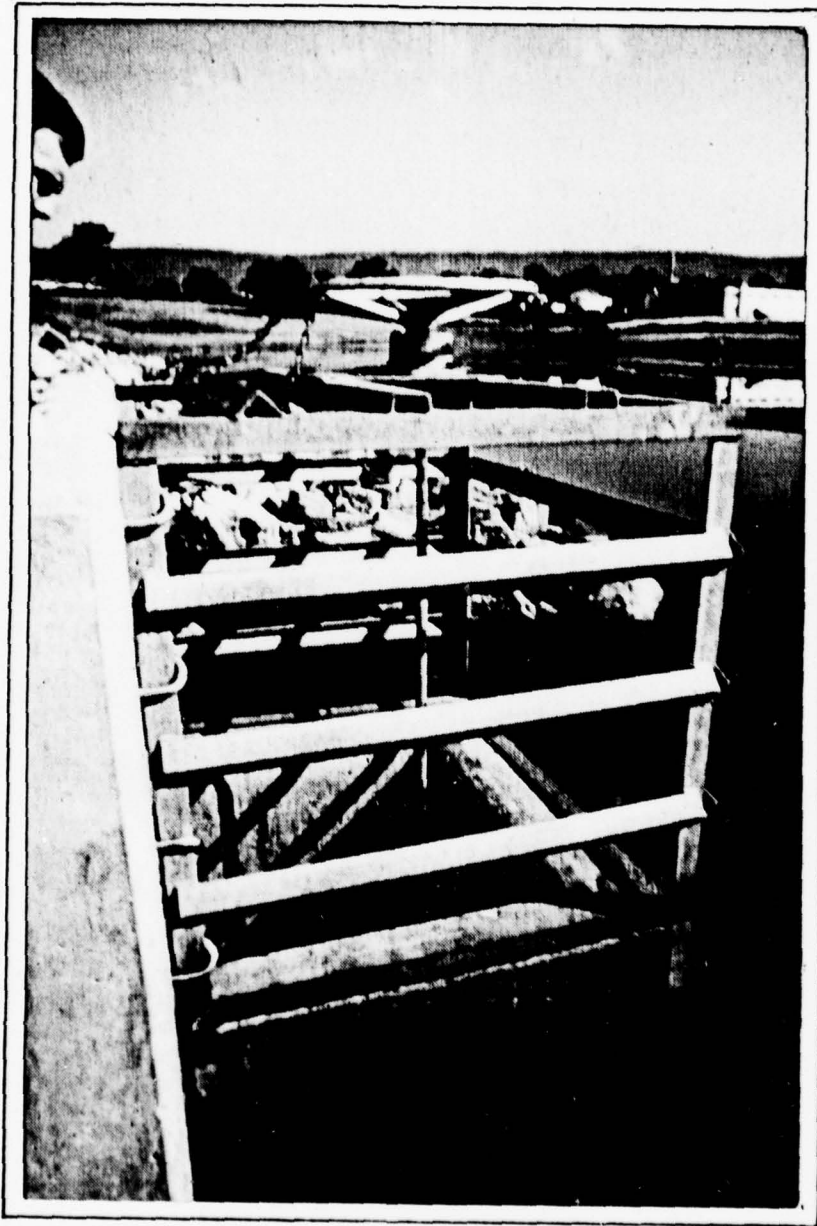
The inspection of the dam disclosed no evidence of apparent past or present movement that indicates existing instability of the dam, emergency or principal spillways. Since a key was not available to unlock the pond drain gate, the gate could not be exercised and could not be confirmed that it was operable. However, the gate system was cleaned, greased and in apparently good condition.

VIEW OF INTAKE RISER, TRASH  
RACKS AND POND DRAIN VALVE.

of Kaercher Creek Dam. It is recommended that a key for the pond drain be retained at the Borough offices in the event that it is necessary to drain the reservoir.

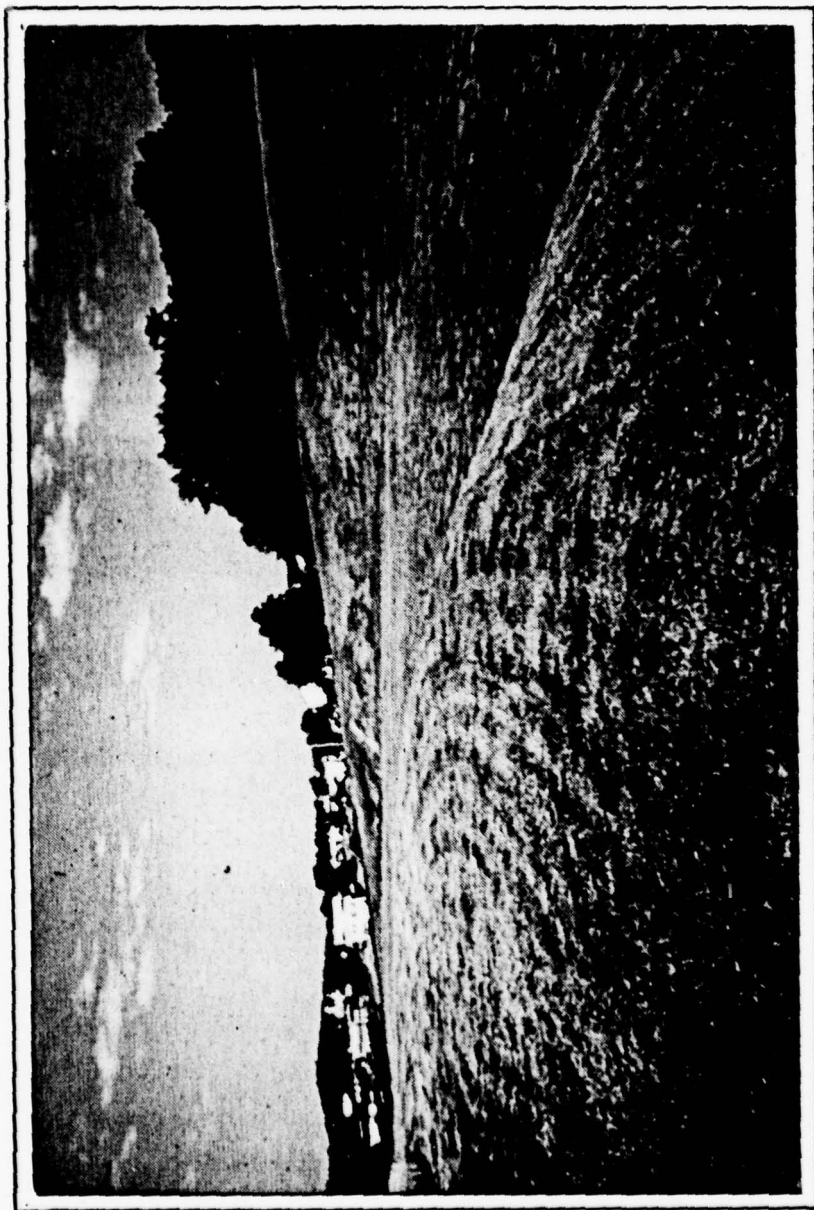
PHOTOGRAPH NO. 7

The grass channel of the emergency spillway side slopes were inspected and observed to be in good condition. There were no signs of significant deterioration, erosion or movement. The grass was lush, well maintained and in very good condition.

EMERGENCY SPILLWAY LOOKING DOWNSTREAM  
JUST UPSTREAM OF CONTROL SECTION.

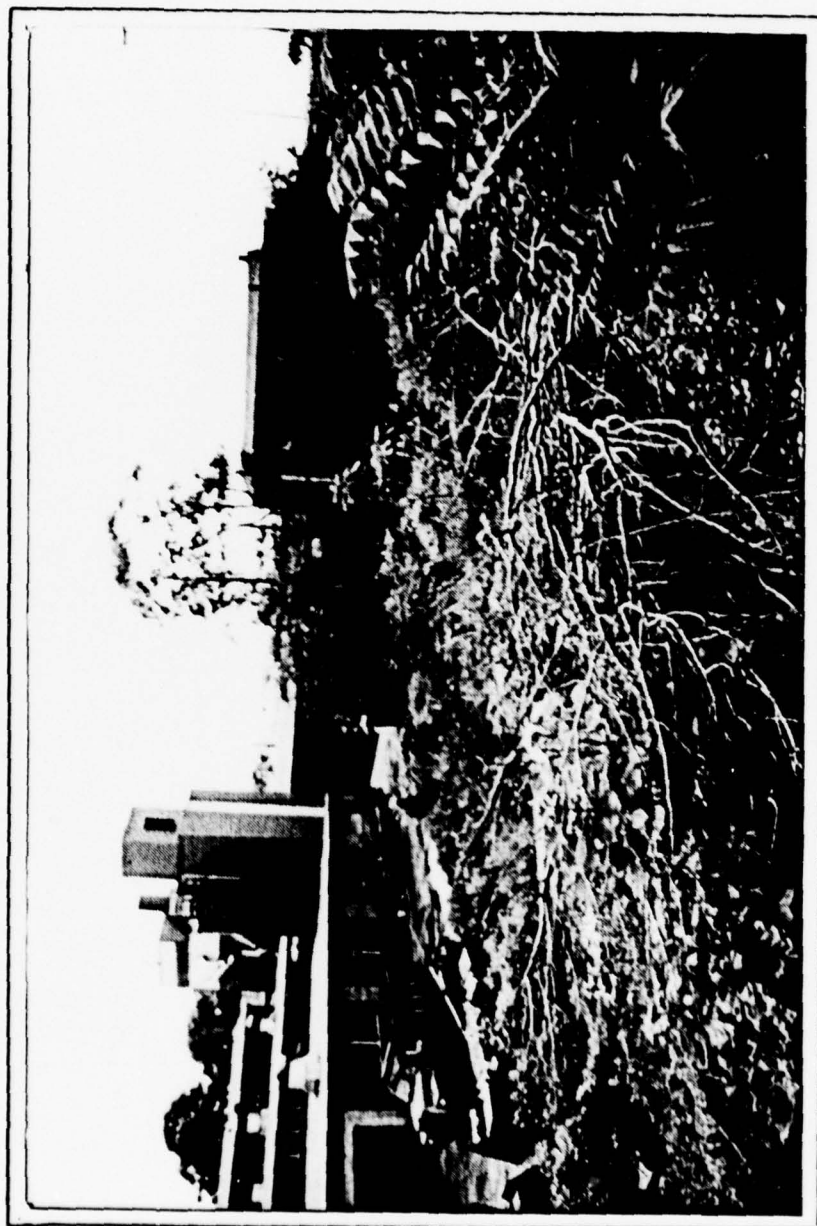
There was no debris noted in the reservoir or near the principal and emergency spillways. Downstream, significant debris and factory storage areas were noted on the flood plain. It is judged that, in the event of high flows along Kaercher Creek, debris would most likely be floated down the channel and would probably clog either the entrance to the tunnel or at the bend in the tunnel under the Hamburg Plow Works factory. This would store water eventually causing damage to the factory and to the homes in Hamburg. Additional evaluations of the flooding potential in Hambrug should be performed.

VUE OF INDUSTRIAL AREA (HAMBURG FLOW  
FACTORY) WHERE STREAM FLOWS VIA A CON-  
DUIT BENEATH THE FACTORY.

Since there are no formal warning procedures, it is recommended that a procedure be developed so downstream residents, including the industrial areas, be amply warned of possible high flows or potentially hazardous conditions. Operational procedures should also be formalized and documented together with a maintenance procedure and inspection checklist.
